Examples of practices: Non-destructive techniques

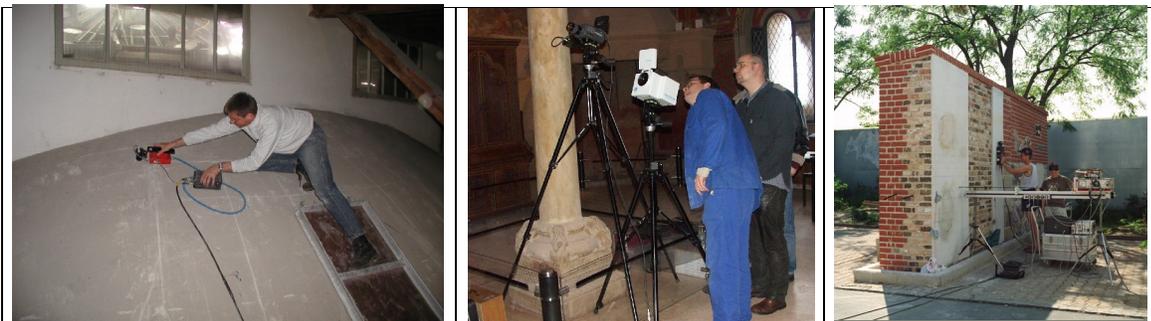
Left: Recording of radar data at the top of the cupola of the Altes Museum in Berlin. Middle: Application of active thermography at the Wartburg in Eisenach. Right: Test specimen made of historic brickwork at BAM.
